Construction Analysis of Plastic Encapsulated Microcircuits Containing Copper Bond Wire

Failure and Material Analysis Branch, NSWC Crane Division

18 June 2018

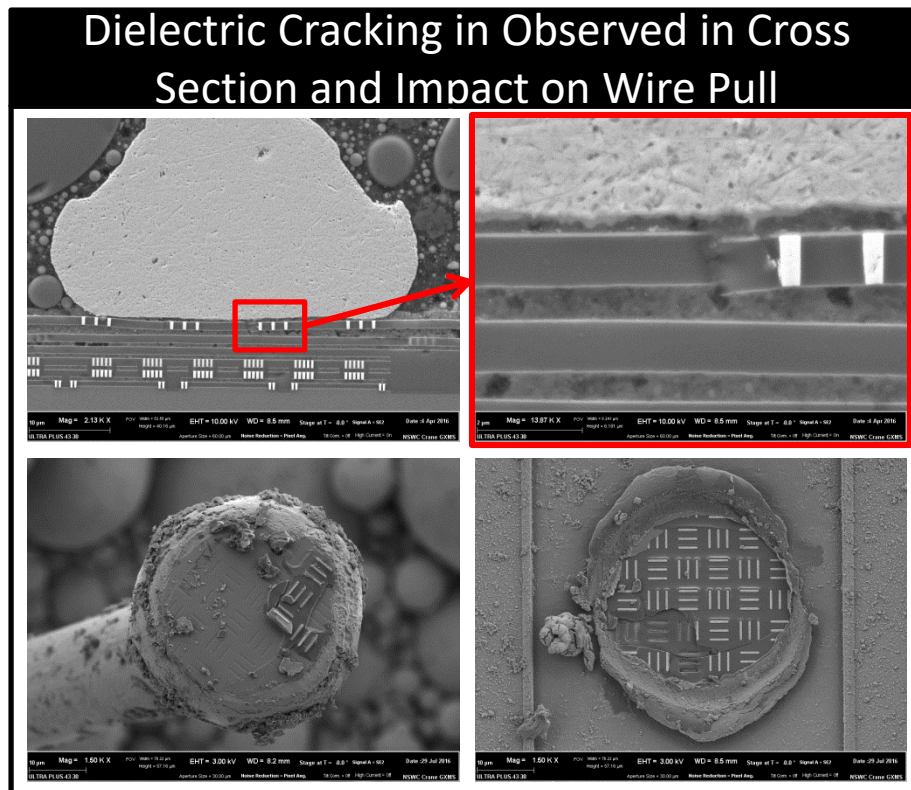
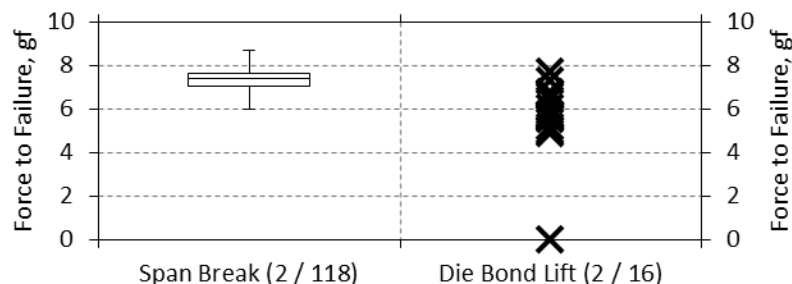
Example 1: Cracked Dielectric

- MA-16-008-01 (Crane Analysis #)
 - Low-cost commercial FPGA
 - Significant dielectric cracking observed in cross section
 - 16 of 134 (12%) of wires pulled failed via die bond lift
 - 20% reduction in pull strength correlated to die bond lift failure mode, including one <1g force to failure (shock and vibe concern)
- Manufacturer contacted concerning results. Per manufacturer:
 - Part is intended to be a low-cost commercial FPGA
 - Manufacturer maintains a gold-wire alternative for automotive industry to meet the automotive reliability requirements

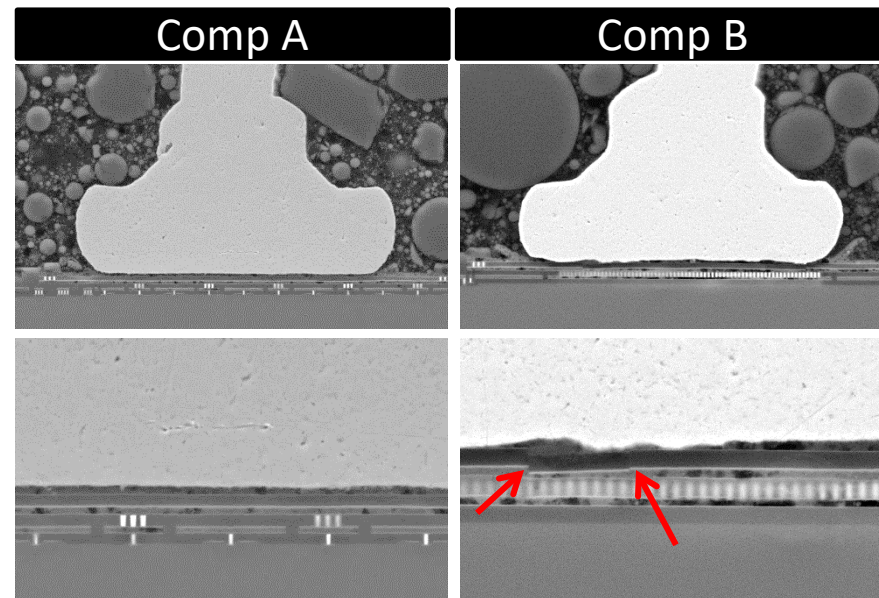
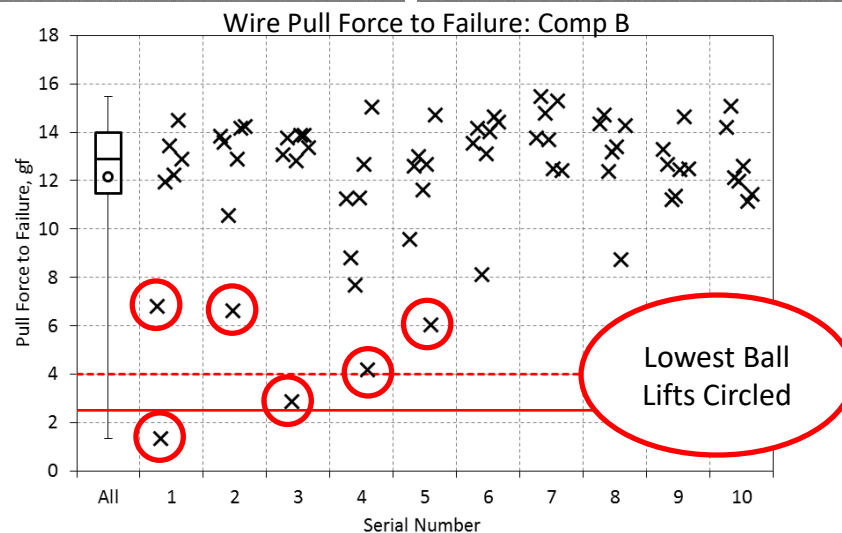
Example 2: Manufacturer Comparison

- Comparison of components MA-16-008-02 (Comp A) and MA-16-008-25 (Comp B) from same manufacturer
 - Both use palladium coated copper wire
 - Both bonded to aluminum with intermetal dielectric
 - Comp A had ‘ideal’ ball bond morphology without dielectric cracking; comp B had an uneven bond floor with dielectric cracking
 - Comp B exhibited multiple die bond lifts; comp A did had none
- Use of palladium coated copper does not guarantee manufacturing success
- Correlation shown between bond morphology and wire pull force to failure/failure mode for other components, including bonds to Al on Si, Al on W on Si, and Al on SiO₂ to Si
 - Not a function of manufacturer (i.e. manufacturer and past experience cannot necessarily be used a predictor of quality)

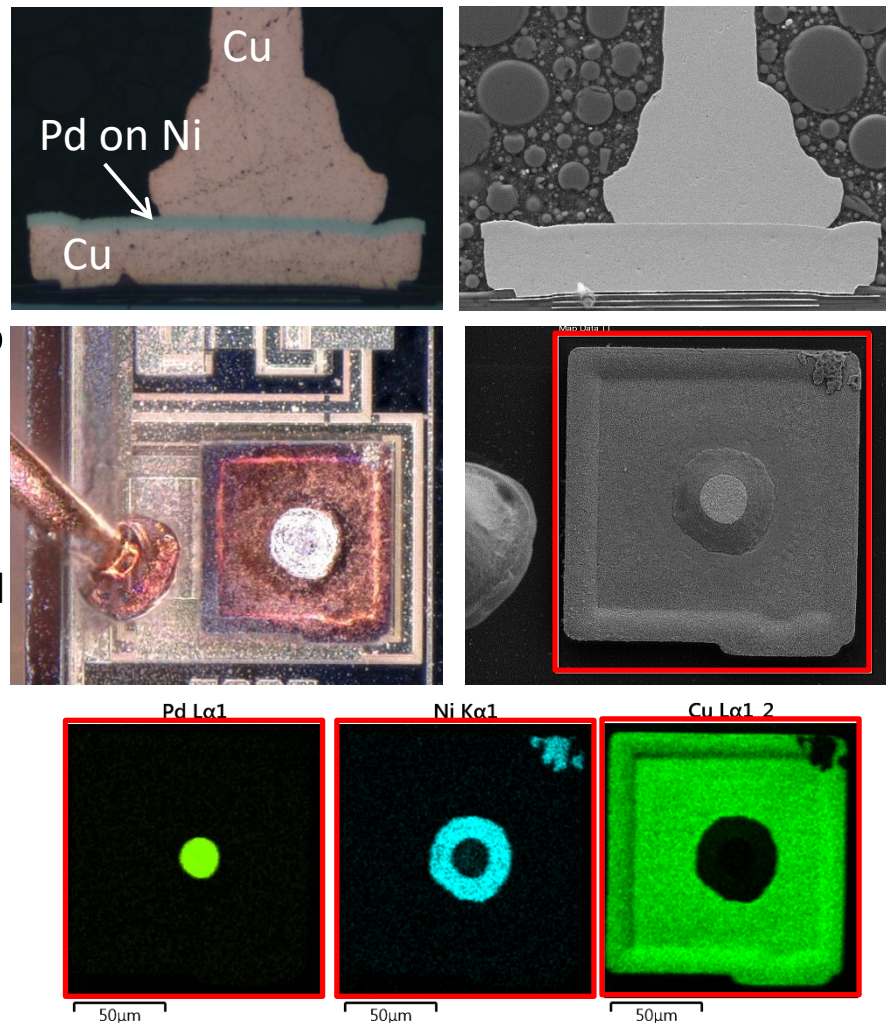
Example 3: Die Bond Pad Adaptation for Copper Wire

- MA-16-008-14
 - Thick copper pad grown on die, finished with palladium on nickel
 - Thicker pad would accommodate higher bonding forces without damaging underlying silicon
- Unexpected failure modes related to die bond lifts were observed including:
 - **Incomplete bonding between ball and pad at the bond center**
 - Incomplete bonding between the ball and pad along an axis
 - Lifting of the nickel plating from the copper pad
- Adapting the die for copper bond wire does not guarantee success and may introduce new failure modes

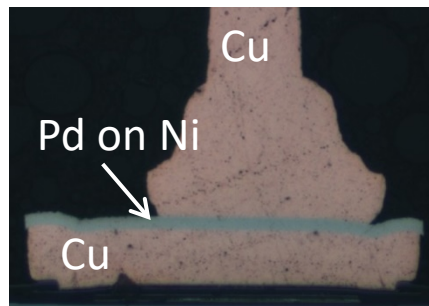
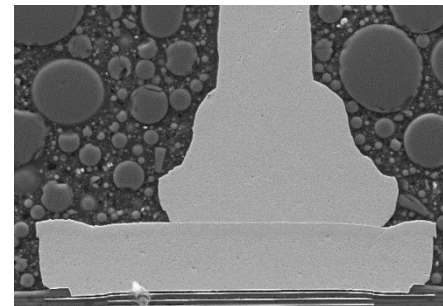
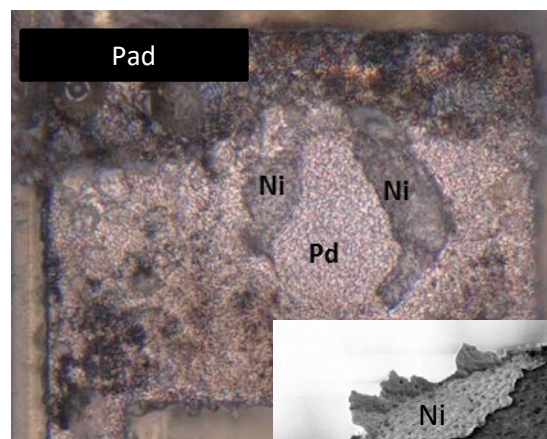
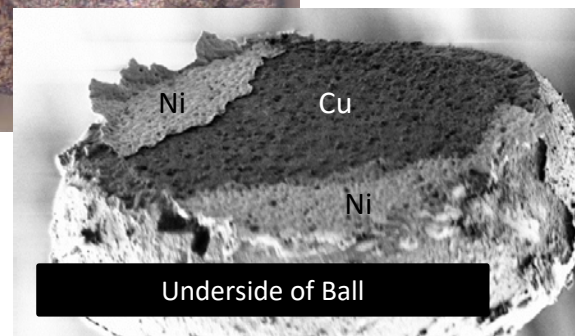
Example 3: Die Bond Pad Adaptation for Copper Wire

- MA-16-008-14
 - Thick copper pad grown on die, finished with palladium on nickel
 - Thicker pad would accommodate higher bonding forces without damaging underlying silicon
- Unexpected failure modes related to die bond lifts were observed including:
 - Incomplete bonding between ball and pad at the bond center
 - **Incomplete bonding between the ball and pad along an axis**
 - Lifting of the nickel plating from the copper pad
- Adapting the die for copper bond wire does not guarantee success and may introduce new failure modes

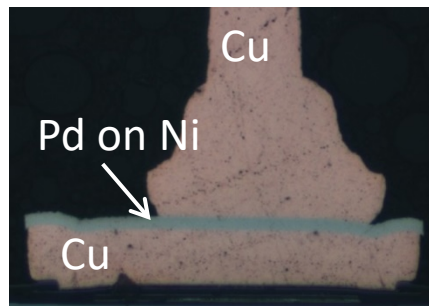
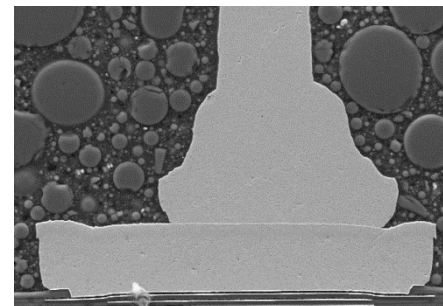
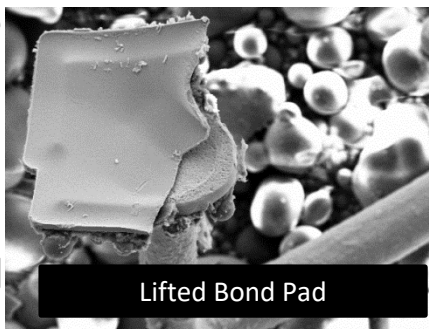
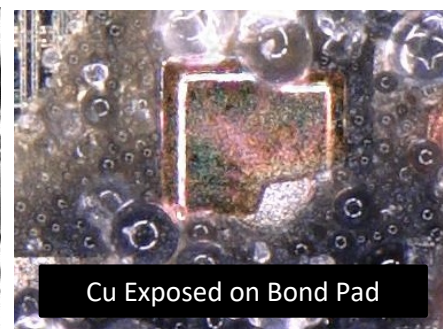
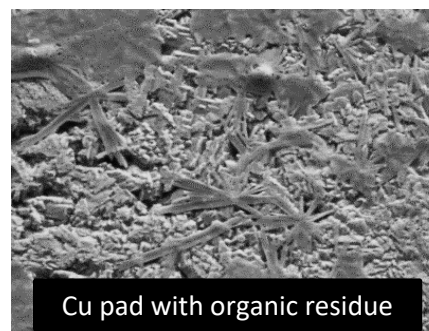
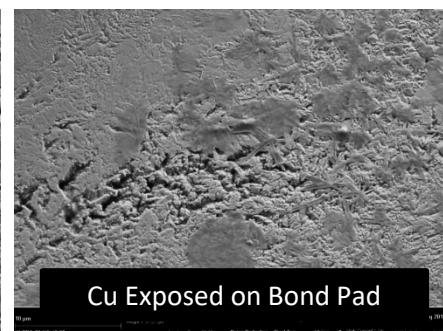
Example 3: Die Bond Pad Adaptation for Copper Wire

- MA-16-008-14
 - Thick copper pad grown on die, finished with palladium on nickel
 - Thicker pad would accommodate higher bonding forces without damaging underlying silicon
- Unexpected failure modes related to die bond lifts were observed including:
 - Incomplete bonding between ball and pad at the bond center
 - Incomplete bonding between the ball and pad along an axis
 - **Lifting of the nickel plating from the copper pad**
- Adapting the die for copper bond wire does not guarantee success and may introduce new failure modes

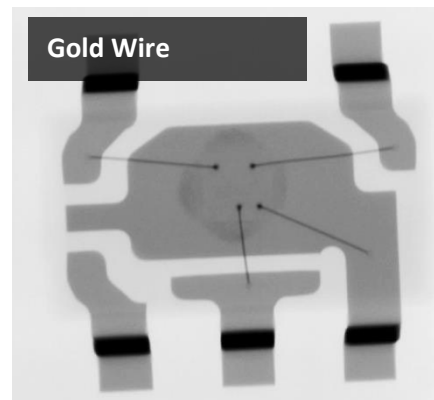
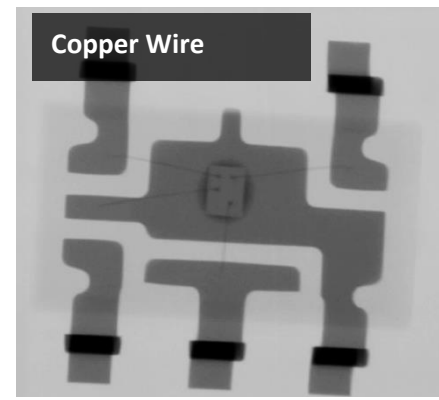
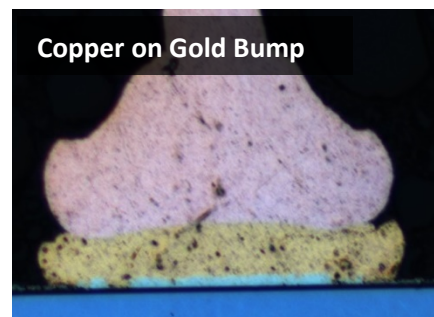
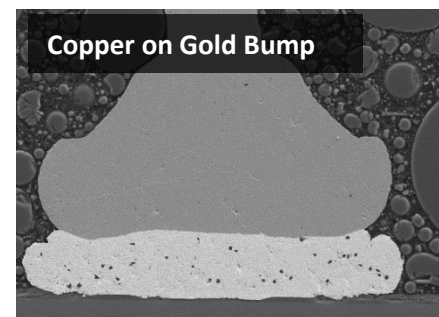
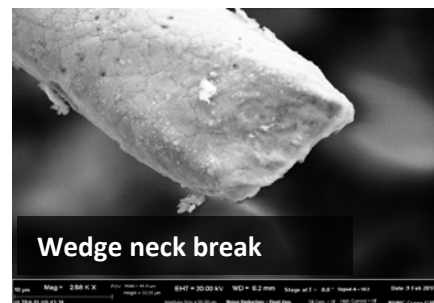
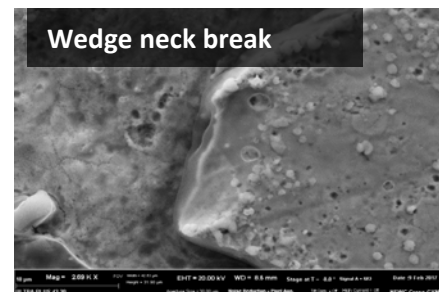
Other Significant Findings Summary

- The transition date to copper bond wires cannot be determined from manufacturer's product change notifications
- It cannot be assumed that once a manufacturer transitions to copper bond wires, future productions runs will use copper wires or that that determination that a date code with gold wires exonerates previous date codes as having copper wire
- Additional changes to the packaging may occur with the transition to copper bond wires
- X-ray inspection is an effective technique to non-destructively determine if a component has copper or gold bond wires
- The current state of the copper wire bonding process results in manufacturing process indicators and defects not typically seen from the gold wire bonding process
- Construction analysis is capable of detecting process indicators specific to the copper wire bonding process including defects at the die and lead frame bonds

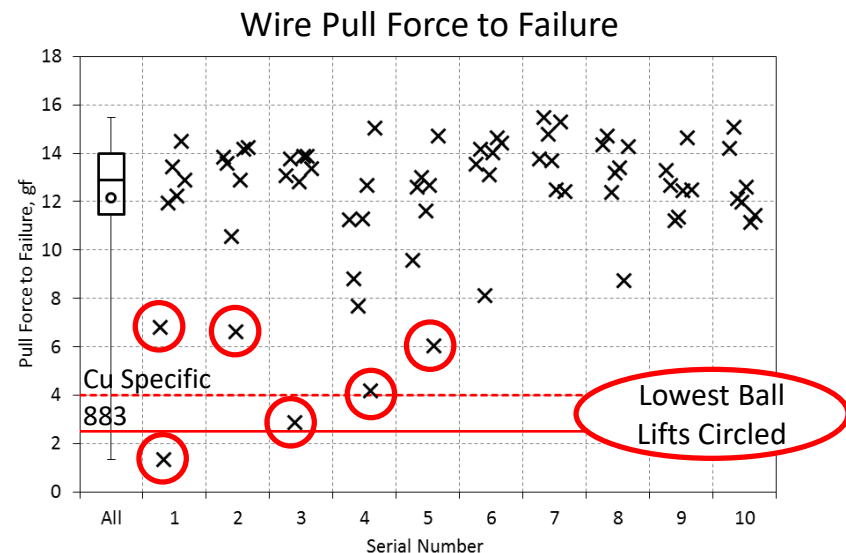
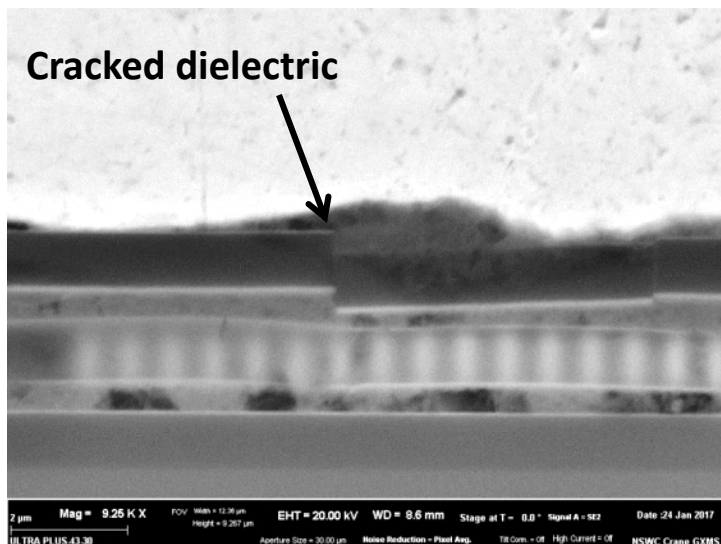
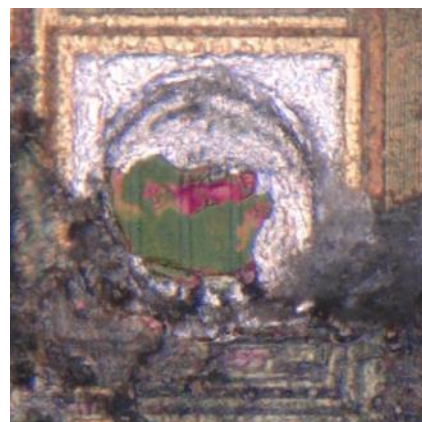
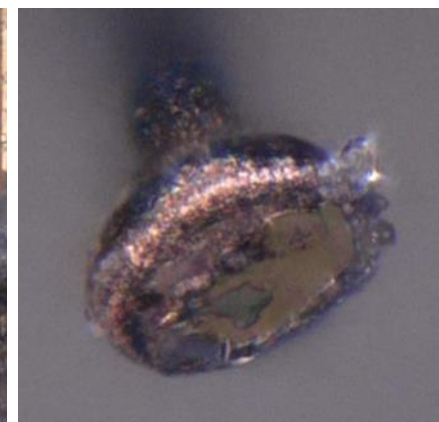
Ex. Cracked dielectric with ball lifts

- Cu on Al-IMD on SiO₂ on Si
 - Cracked dielectric observed in cross section and wire pull (rejection criteria)
 - Standard Deviation > 10% average (rejection criteria)
 - 2x failure to meet enhanced pull criteria
 - 1x failure to meet 883 criteria
- Should this lot be rejected?
 - What if SN1 and SN3 weren't tested?

Ball bond lift with cracked dielectric: Force to failure, 1.3gf.

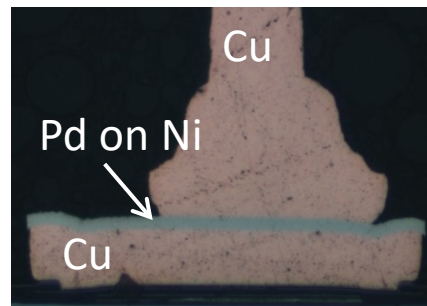
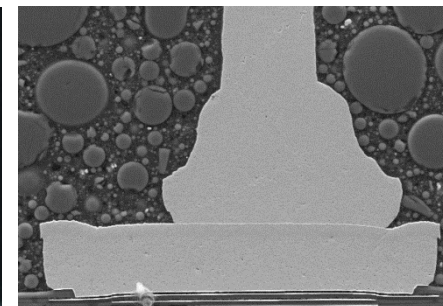
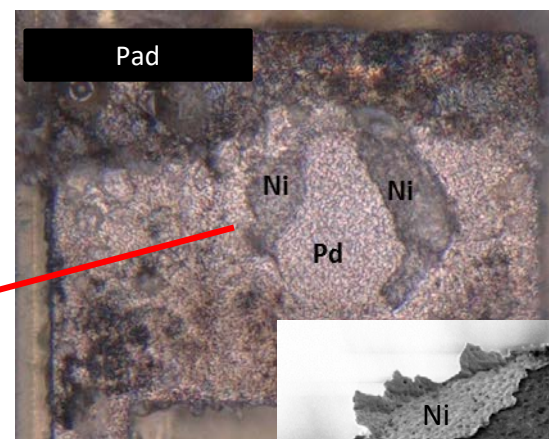
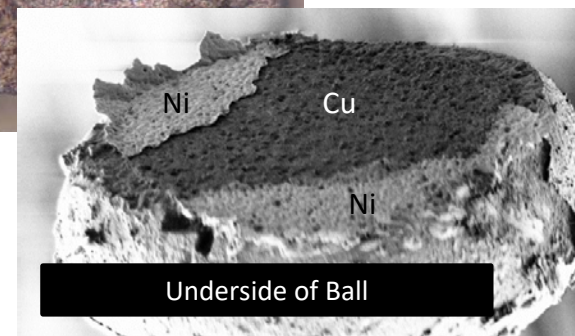
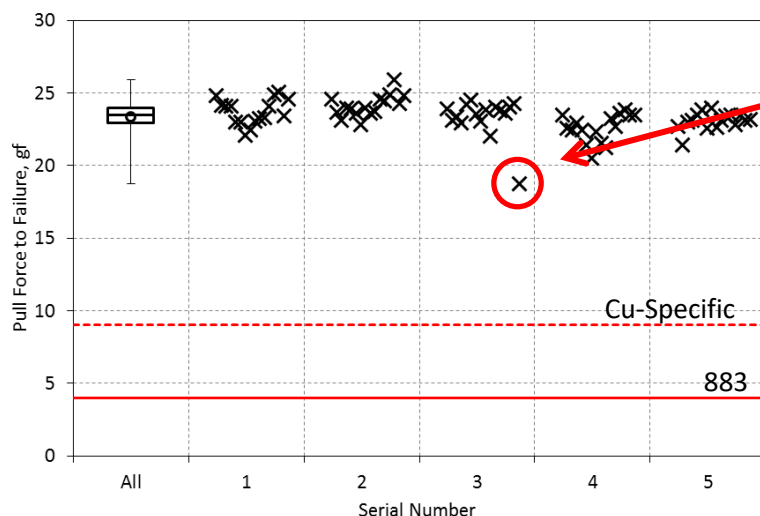
Ex. Non-standard bond pad with ball lift

- Cu on Pd on Ni
 - No IMC formation between Cu and Ni (cannot inspect to IMC criteria)
 - Ball lift shows an effective bonding area of 55% (rejection criteria: <75%)
 - Ball lifted (rejection criteria: any failure mode but span) but exceeded minimum enhanced pull strength by over 2x
- Should this lot be rejected?

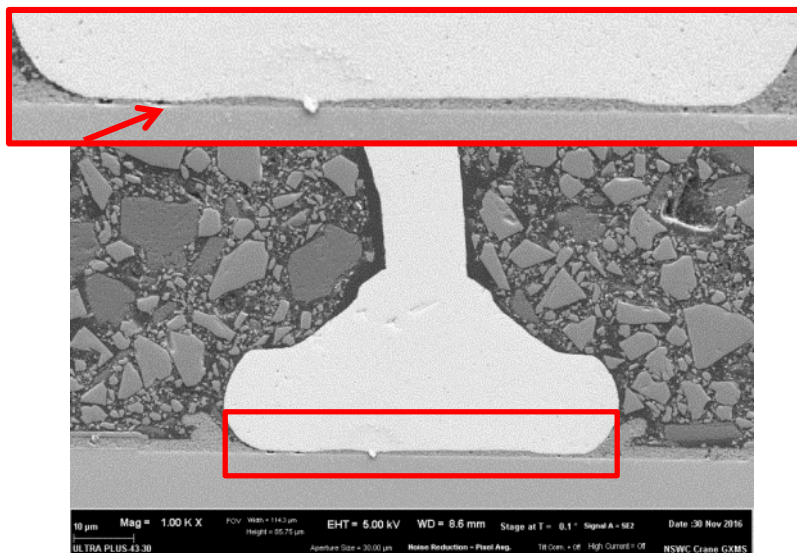
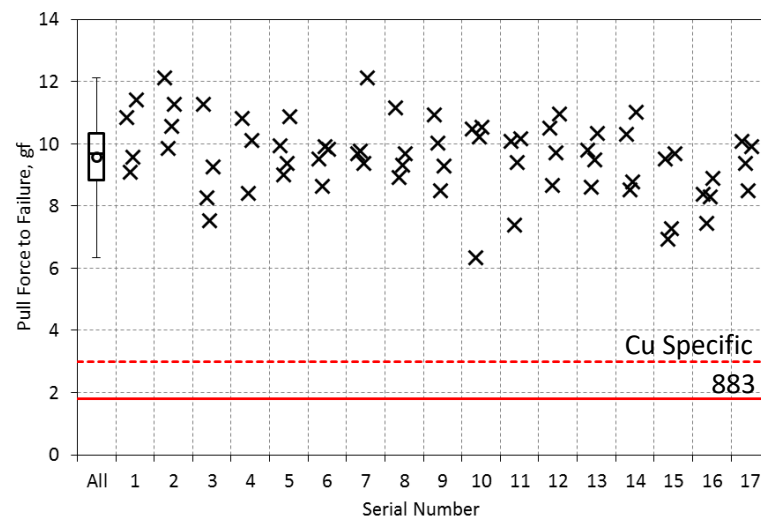
Ex. Less than ideal ball bond formation and bonding

- Cu on Al on Si
 - Aluminum thickness reduced to less than 200nm as observed in cross section, rejection criteria
 - Standard deviation exceed 10% of the average, rejection criteria
 - Non-span, ball neckdown failure modes, rejection criteria
 - All pull forces exceed enhanced criteria by at least 2X
- Should this lot be rejected?

Frequency	Minimum, gf	Average, gf	Standard Deviation, gf
Overall	67	6.3	9.6	1.2
Ball Neckdown	17	6.9	9.1	1.1
Span	50	6.3	9.8	1.2

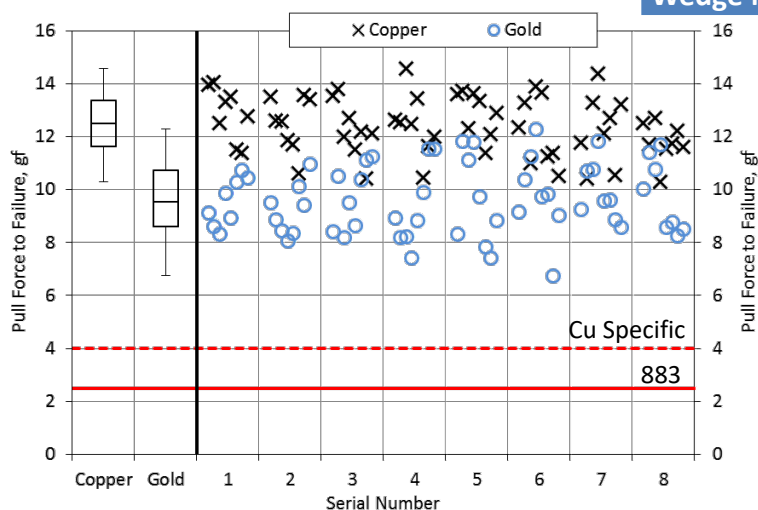
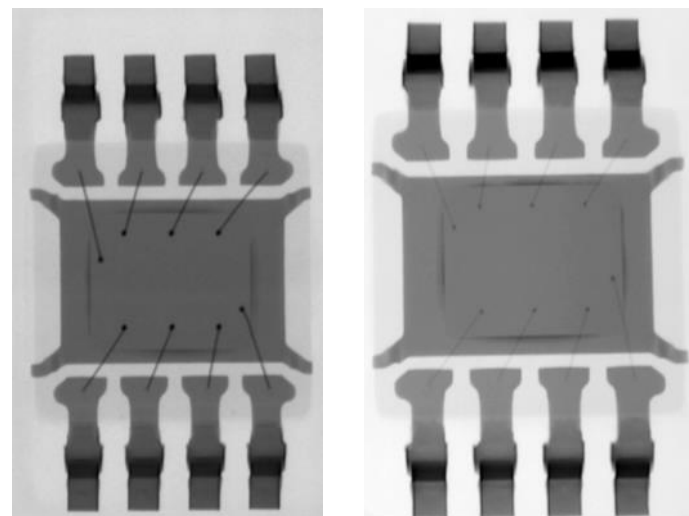
Ex. Gold and copper comparison with non-span failure modes

- Cu vs Au Comparison
 - Ball neck and wedge neck breaks observed in both Au and Cu packages (Cu specific reject criteria)
 - All pulls (Au and Cu) exceeded enhanced pull force requirements
- Should this lot be rejected?

Copper: 64 Wires Pulled			Gold: 64 Wires Pulled		
Failure Mode	Frequency	Ave, gf	Std Dev	Frequency	Ave, gf	Std Dev
All	--	12.42	1.09	--	9.63	1.30
Ball Neckdown	14%	12.78	0.94	16%	10.18	1.35
Span	16%	13.25	1.00	0%	--	--
Die Bond Lift	0%	--	--	0%	--	--
Frame Bond Lift	0%	--	--	0%	--	--
Die Metal Lift	0%	--	--	0%	--	--
Frame Metal Lift	0%	--	--	0%	--	--
Die Fracture	0%	--	--	0%	--	--
Frame Fracture	0%	--	--	0%	--	--
Wedge Neck	70%	12.16	1.05	84%	9.52	1.28

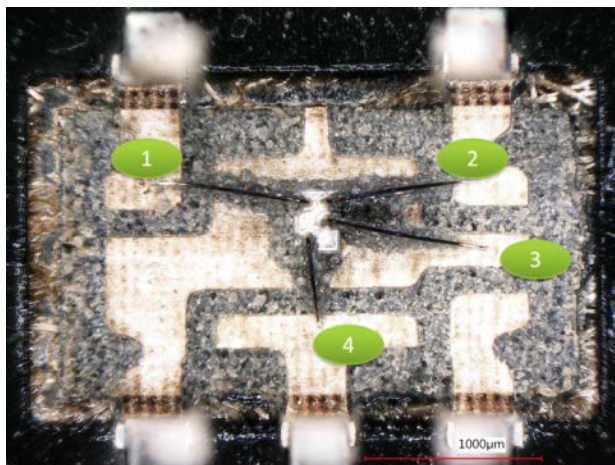
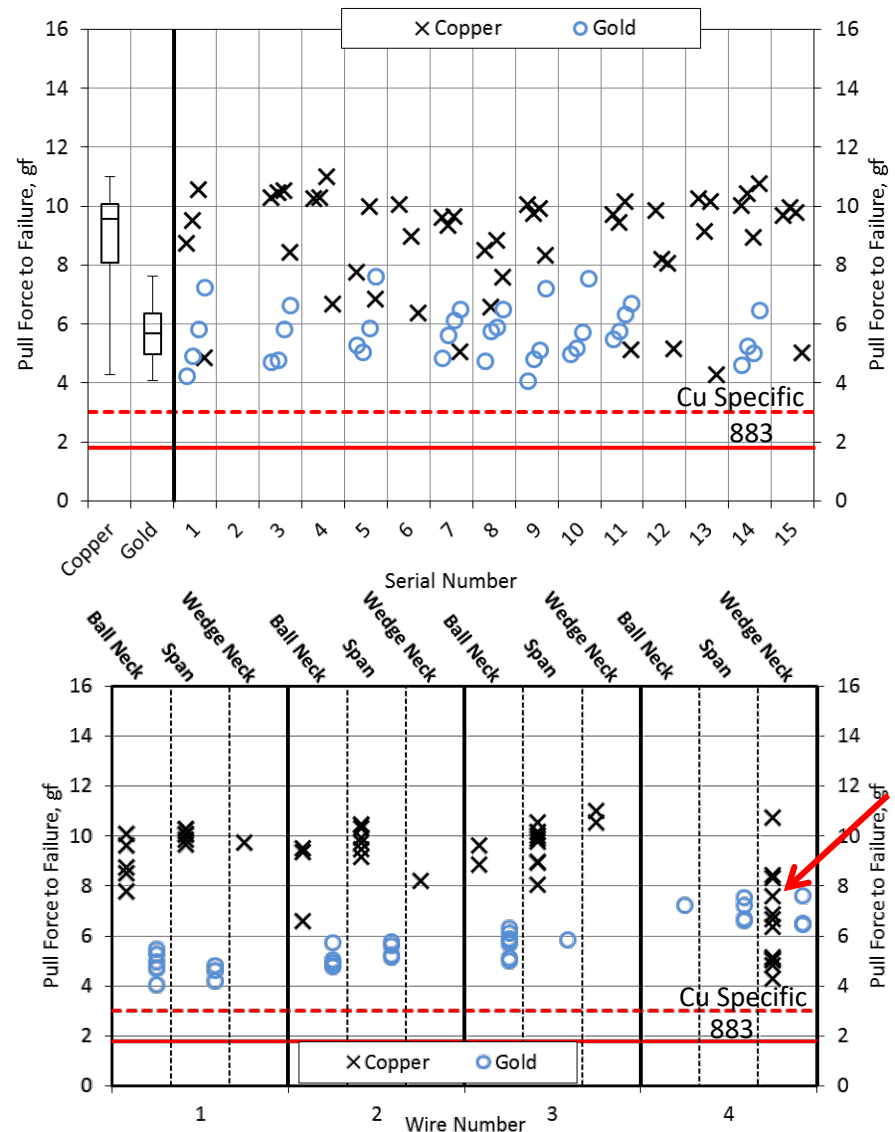
Ex. Gold and copper comparison wire specific concern

- Cu vs Au Comparison
 - Ball neck and wedge neck breaks observed in both Au and Cu packages (Cu specific reject criteria)
 - Wire dependent low force to failure and exclusive wedge neck failure mode (rejection criteria captures in standard deviation requirements)
 - All pulls (Au and Cu) exceeded enhanced pull force requirements
- Should this lot be rejected?
